**ADDENDUM NO. 2**

**REFERENCE:** The College of New Jersey  
Forcina Hall Asbestos Abatement  
Bid No. AB250006

**PRE-RENOVATION ASBESTOS SURVEY**

**FORCINA HALL RENOVATIONS- FO2023  
AVENUE  
EWING, NEW JERSEY**

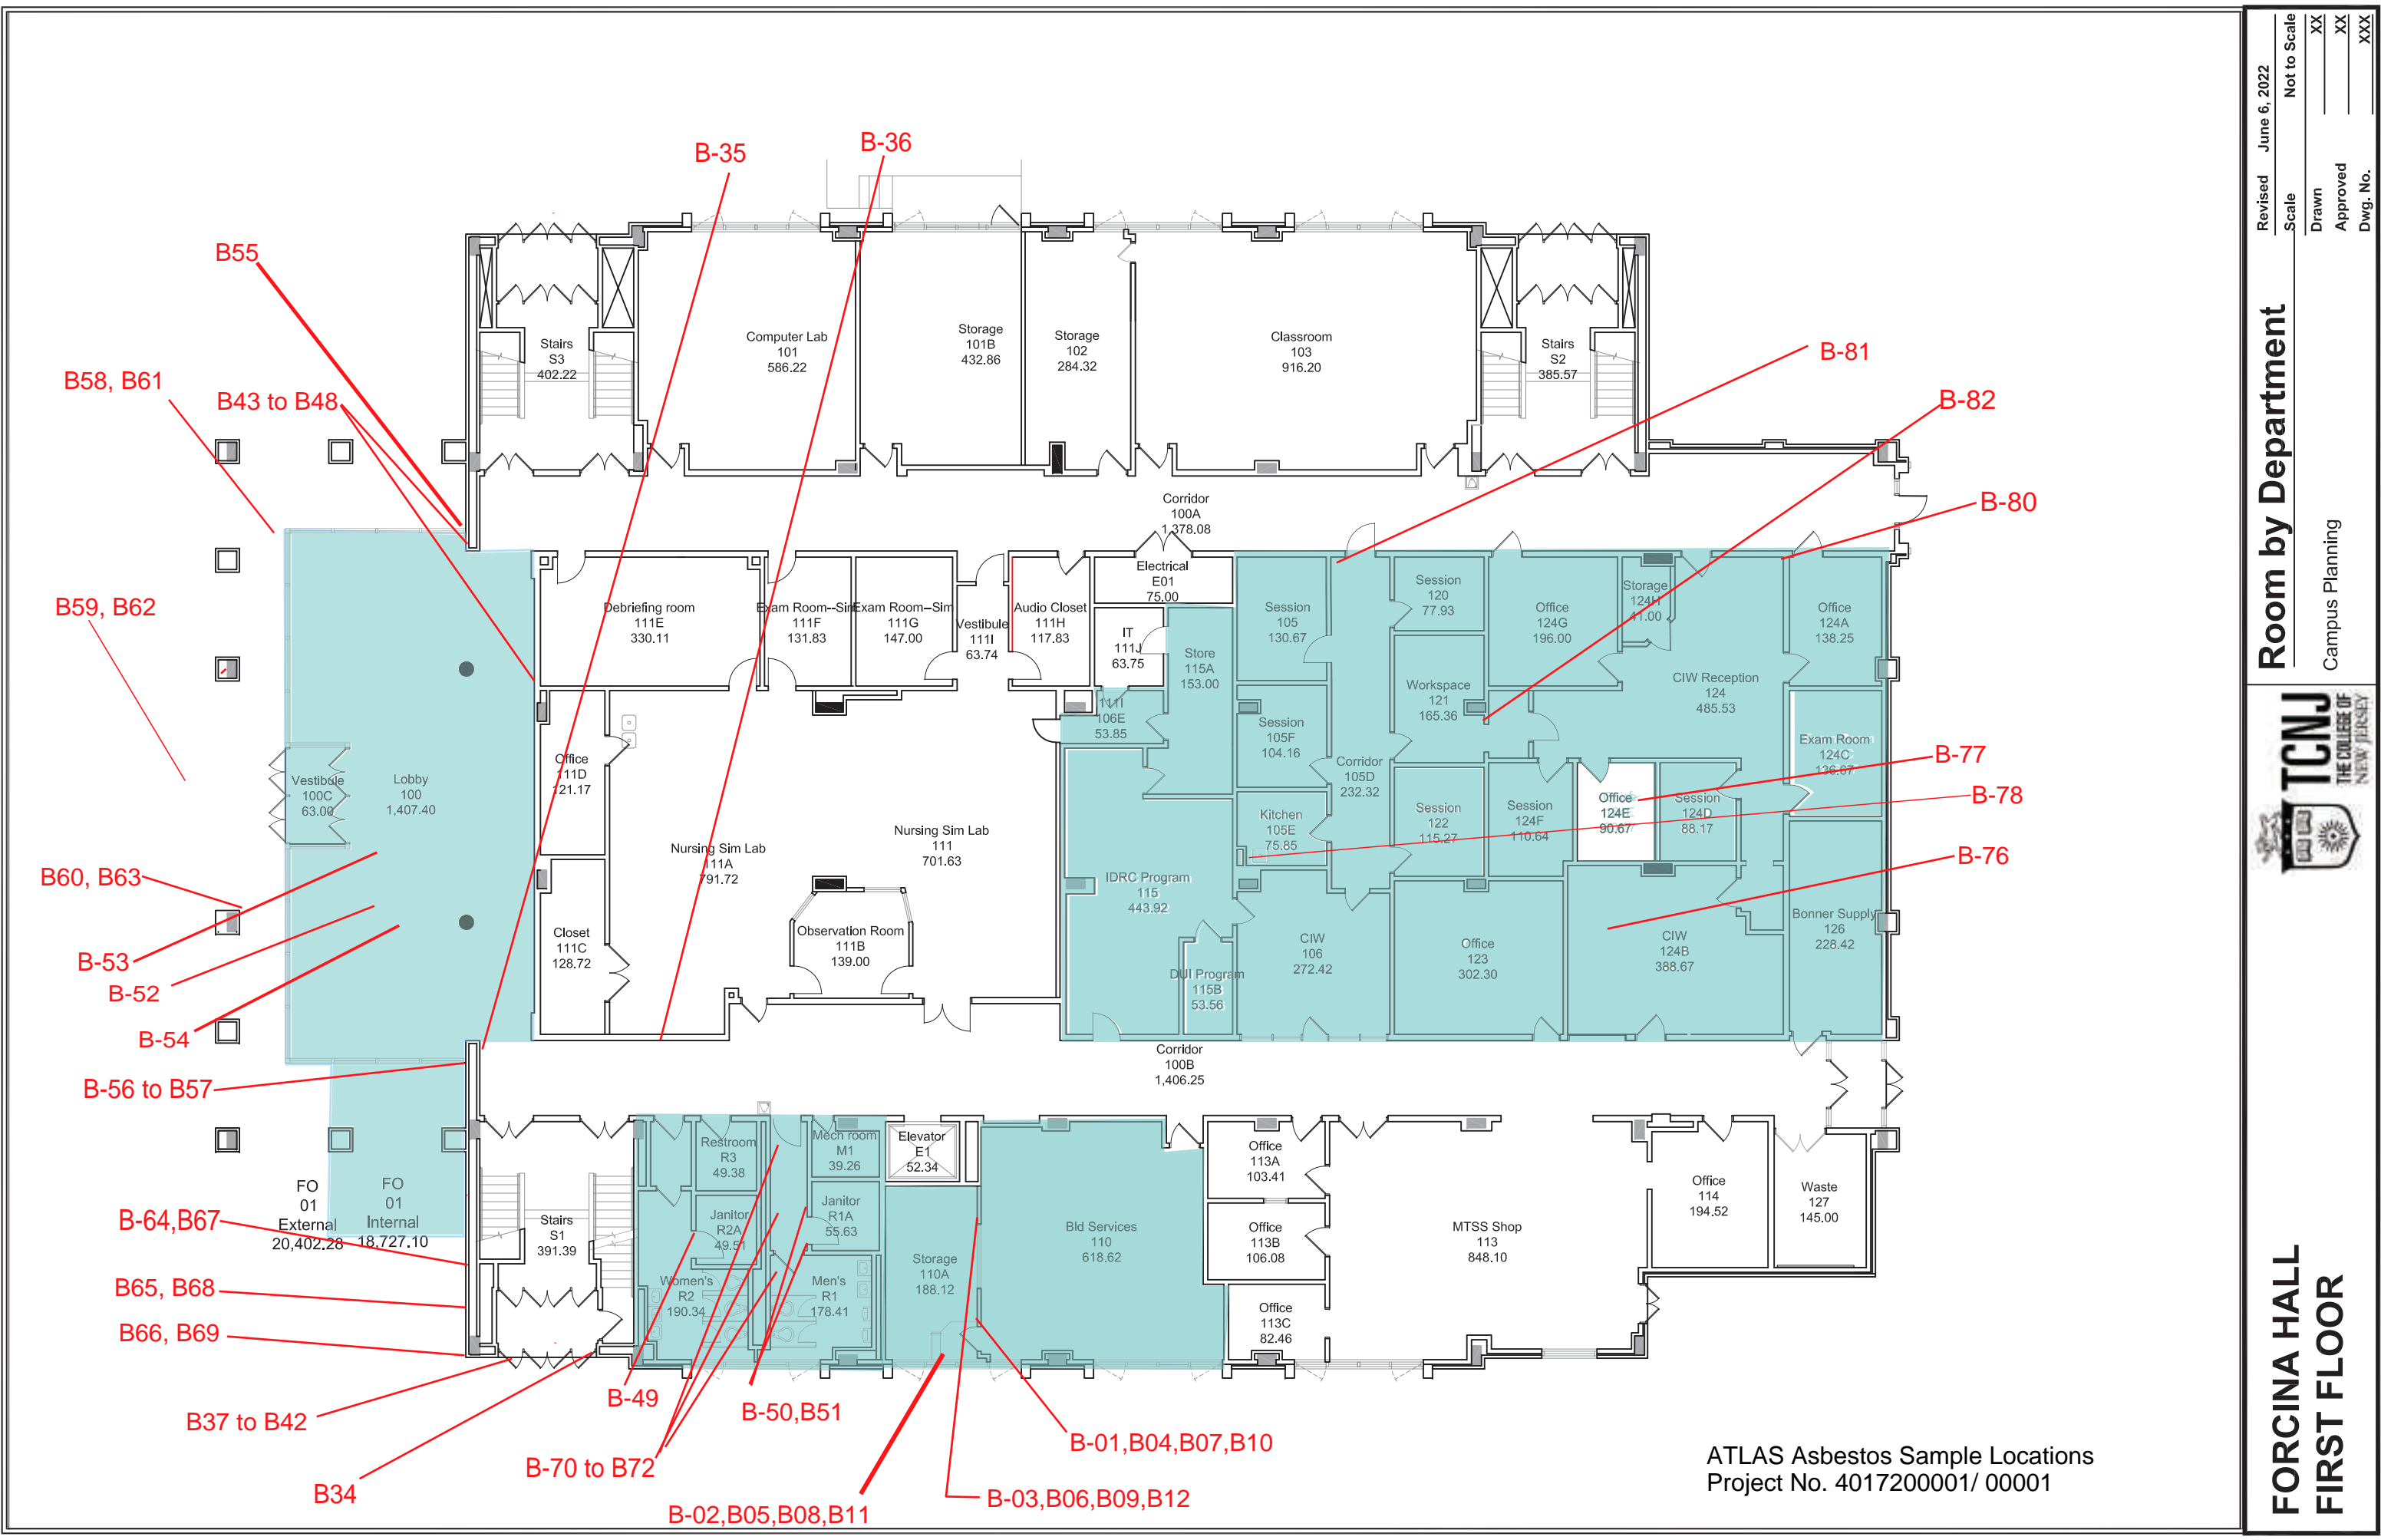
FIRST FLOOR

ATLAS Asbestos Sample Locations  
Project No. 4017200001/ 00001

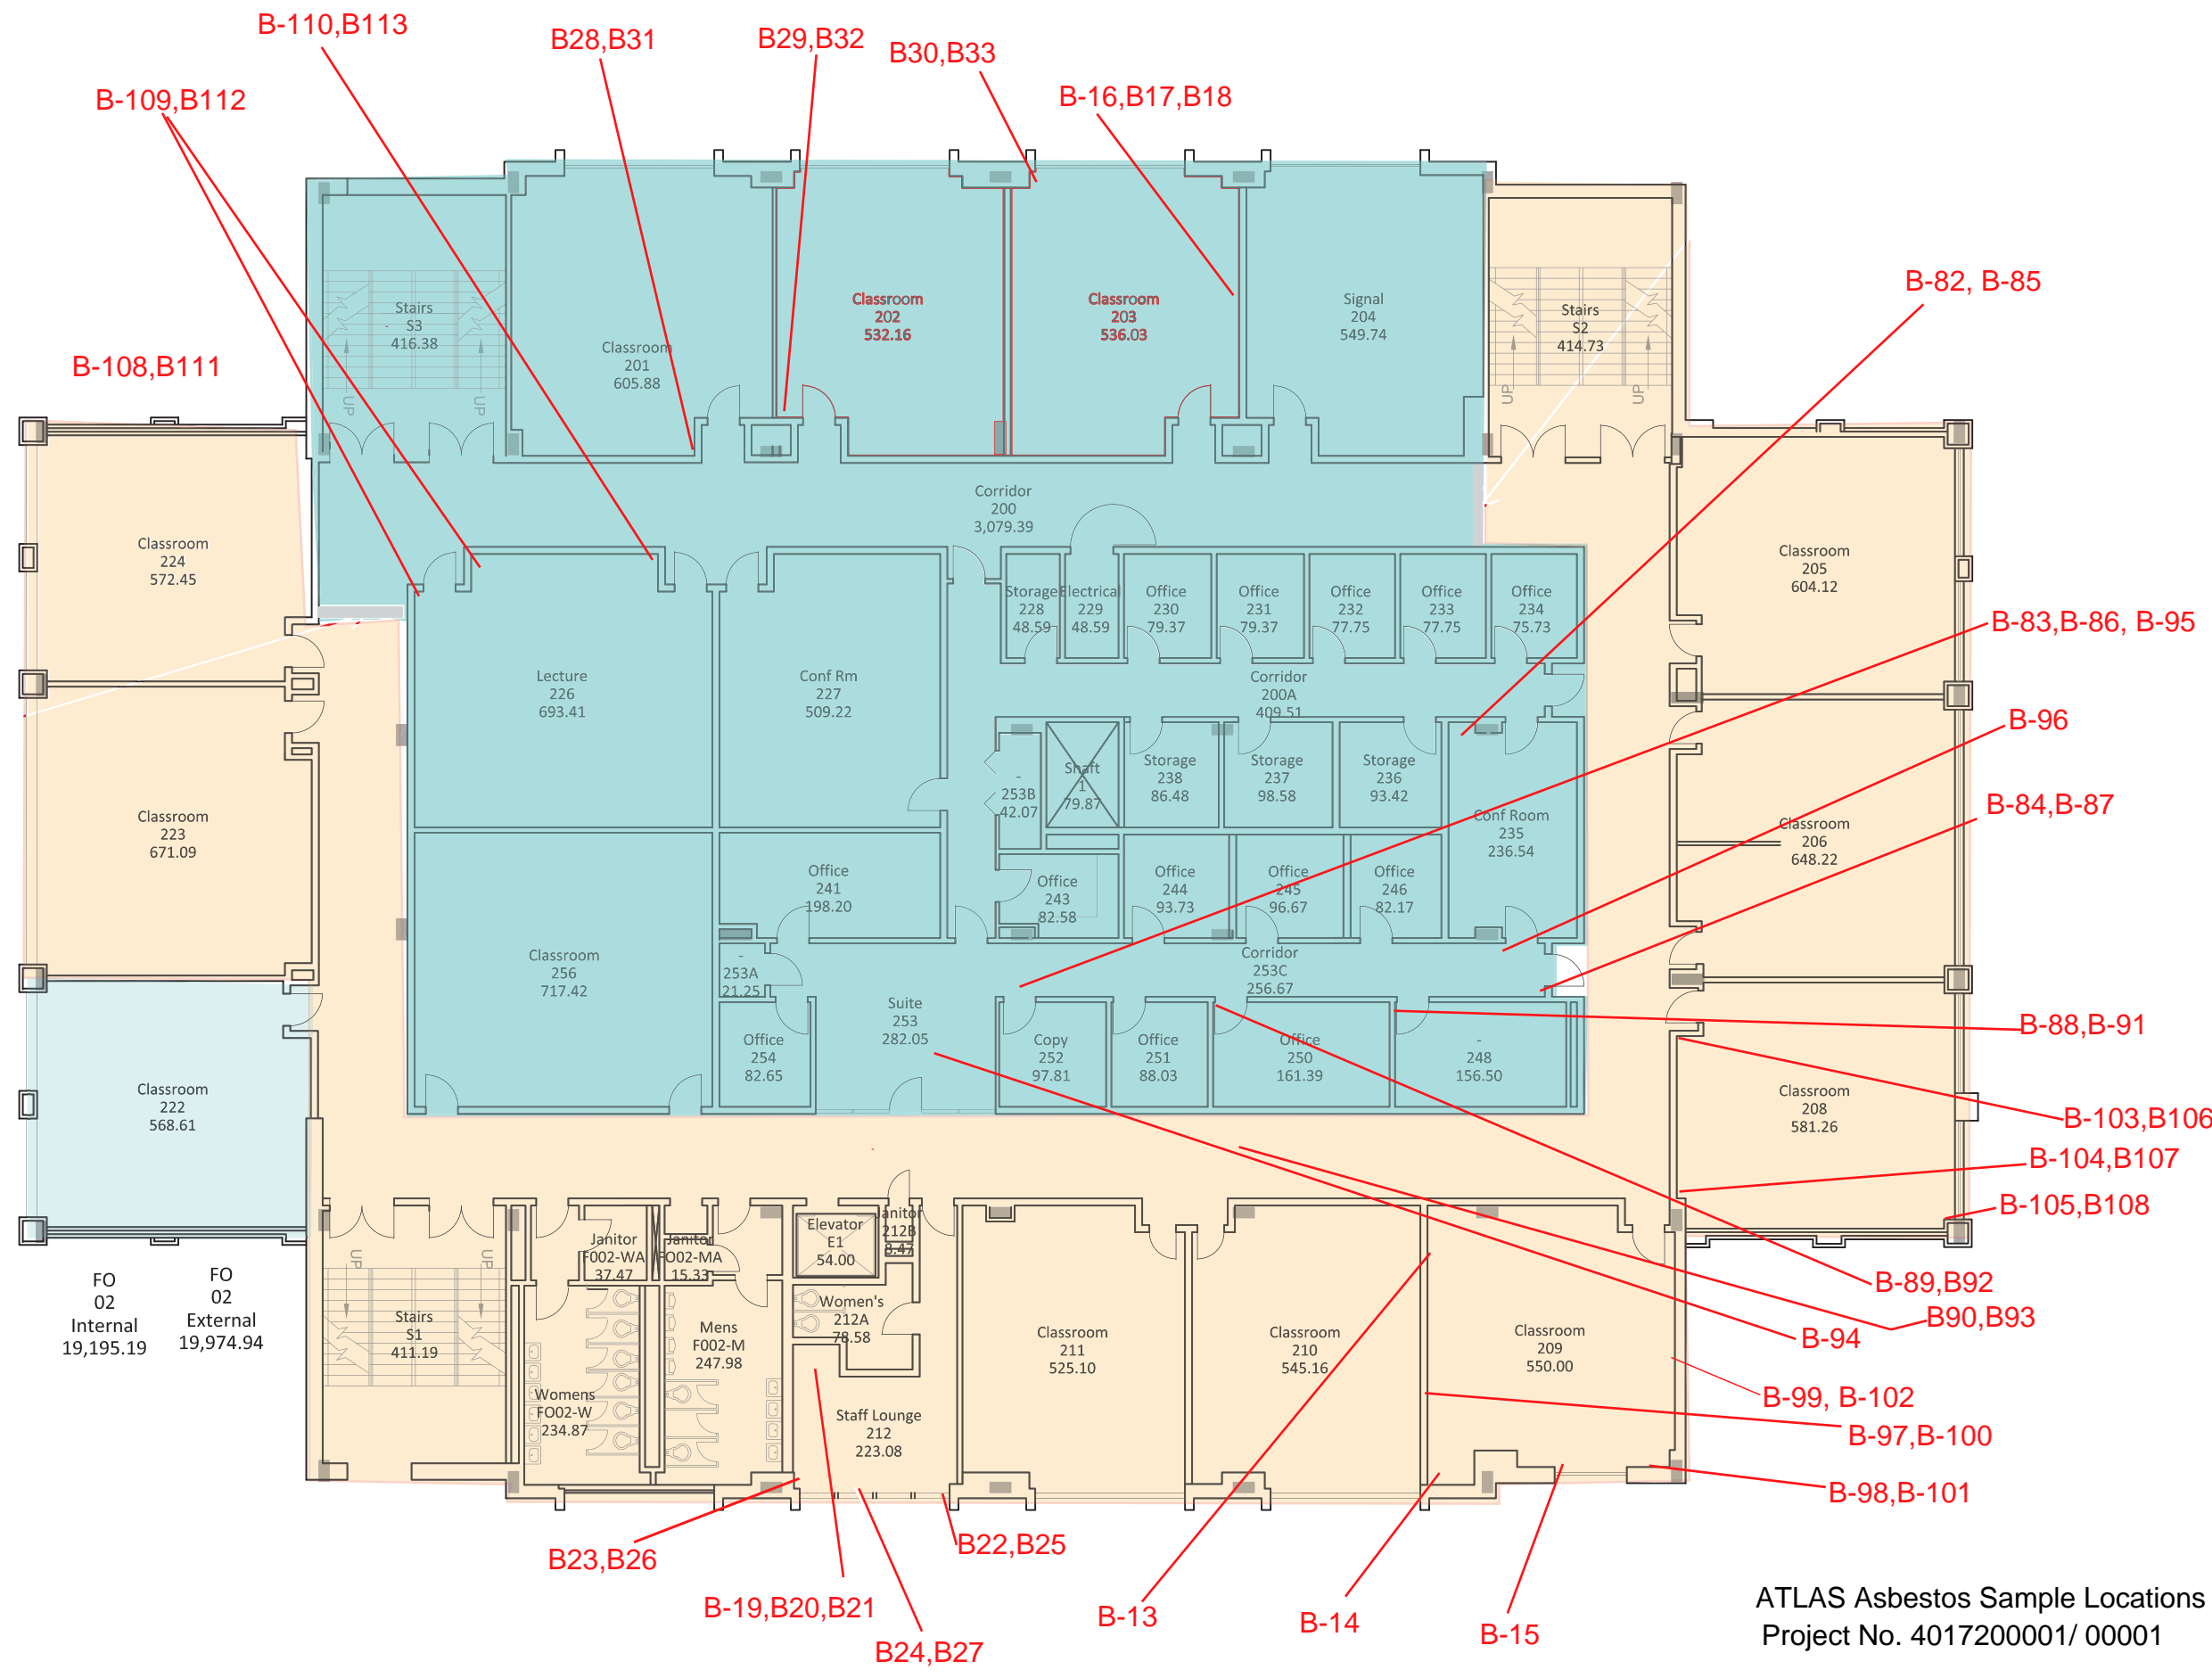
SECOND FLOOR

ATLAS Asbestos Sample Locations  
Project No. 4017200001/ 00001
